FERRO-CEMENT  
BOAT BUILDING MANUAL

VOLUME III

NAVAL SHIP SYSTEMS COMMAND  
WASHINGTON D. C.

This is a record of the building of ten 42-ft. fishing boats in the Bahamas. It illustrates the methods, equipment and organization required to construct ten ferro-cement boats on a remotely situated beach, with relatively unskilled labor.

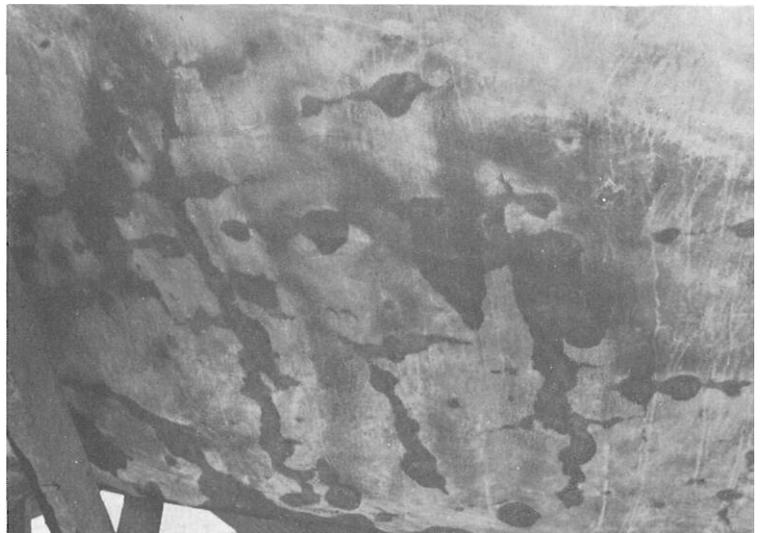
*Stress cracks being sealed with the action of sodium silicate in the water.*

Altogether, some 500 feet (152 m) of hair-line cracks were repaired on this project. But most of these cracks were confined to just four of the ten hulls. There were two reasons for these crack formations. First, the shut-downs in the steam curing cycle caused by the lime content in the Bahamian water. Although extra curing time was given in compensation, some of the cracks undoubtedly relate to the uneven temperature curve caused by these shut-downs. It was fortunate that ambient temperature was around 85° F in Freeport at the time, otherwise more extensive cracks might have occurred.

Checks were made for leaks. Most of the hulls were totally watertight. Some hulls showed a few damp spots which disappeared after a couple of days. Where there were stress, shrinkage or damage cracks, they were repaired. If the damaged area was bad, it was tested once more with water after repair.

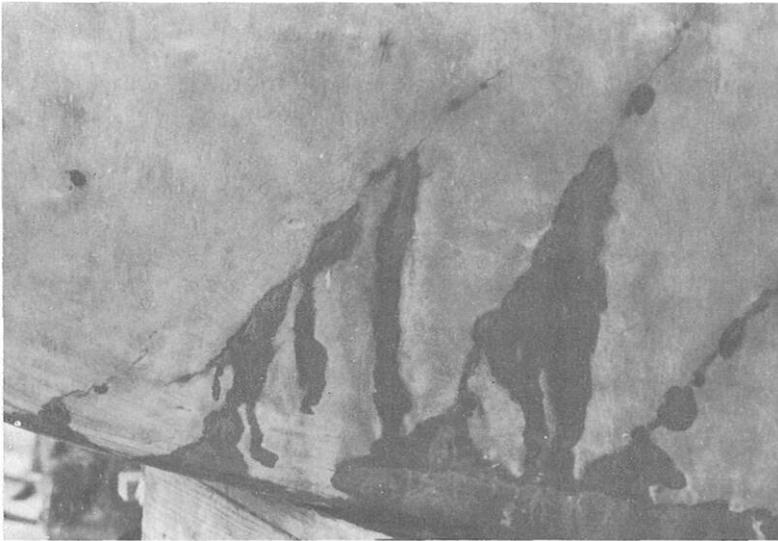
*Stress cracks radiating from the stem. This hull was dropped by the crane.*

The second reason for hull cracks can be traced to the crane operator. He was new to his job and consequently nervous about rolling the hulls. Most crane operators work in straight lifting, moving and lowering sequences. This job required the hull to be lifted, held briefly at a height, then rolled 180°, simultaneously slacking off on one line and tightening up on the other. Two sets of controls and brakes had to be used with great skill at the same time. (It was a credit to the Bahamian crane driver that he learned as fast as he did, as he had nothing to practice with except our boats.) One boat was suddenly dropped from a height of over six feet (1.8 m) on its side when the crane operator's hands and feet became confused in the working of his lifting levers and holding foot-brakes. Three other boats received pretty heavy crane treatment, having their athwartship braces moved several times each time they were lifted and set down because they were not balancing horizontally on the lift. Other damage was caused by men who grew disenchanted stripping out the mold, and would sometimes hammer a crow bar through the hull before throwing down their tools and walking off the job.

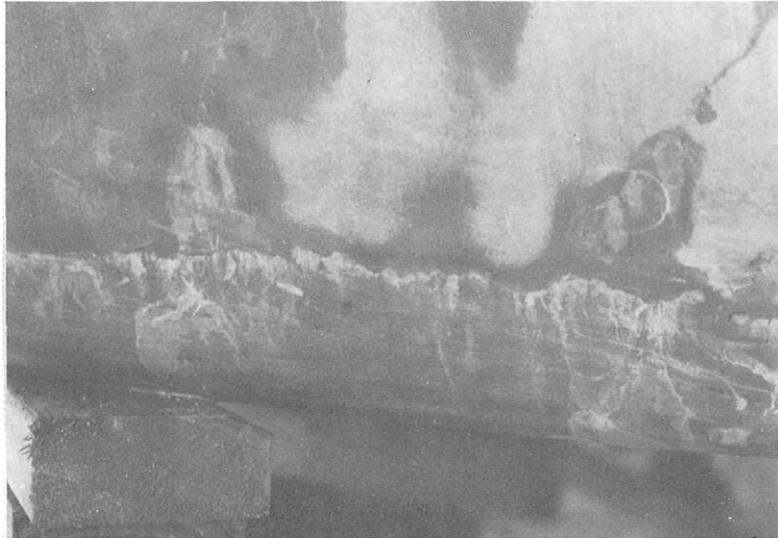
*Sodium silicate forming a seal.*

The water tanks were filled to the top. All through-hull holes were plugged and each section of the hull was filled in turn. All through-bulkhead accesses were blocked to check if each bulkhead was truly watertight. If not, they were repaired. Waterglass, or sodium silicate, was added to the water, approximately five gallons per boat, to seal hairline cracks.

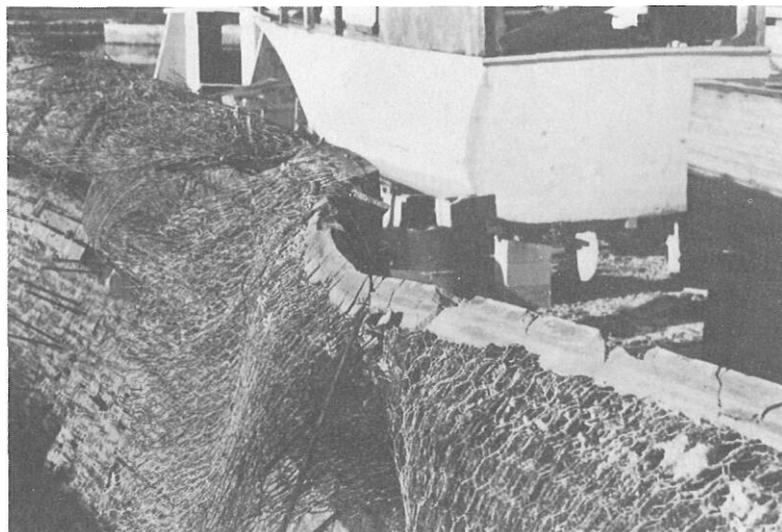
*This hull dropped six feet (1.8 m) onto its side when rolled. It fell on blocks on the concrete pad.*

The dropped hull needed some extensive repair on the top sides along the sheer, where it had suffered the most damage. This was done as follows:

1. The damaged concrete areas were pulverized out.
2. The reinforcing rods were pounded back into shape and faired.

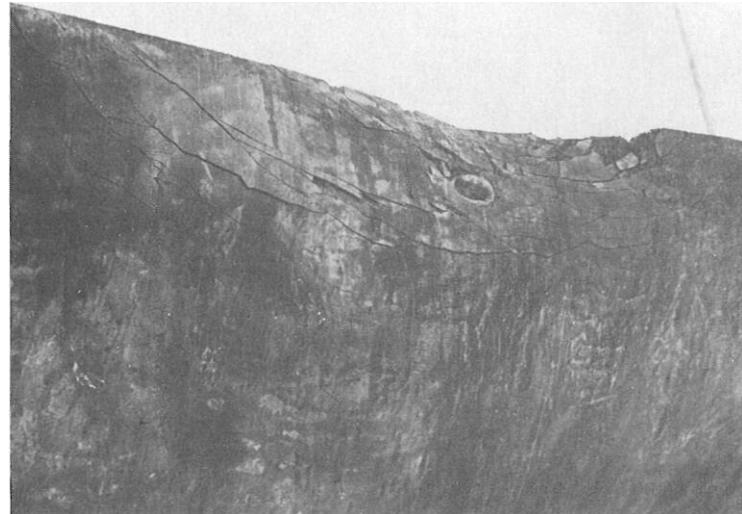
*View from outside of the hull damaged when dropped on its side.*

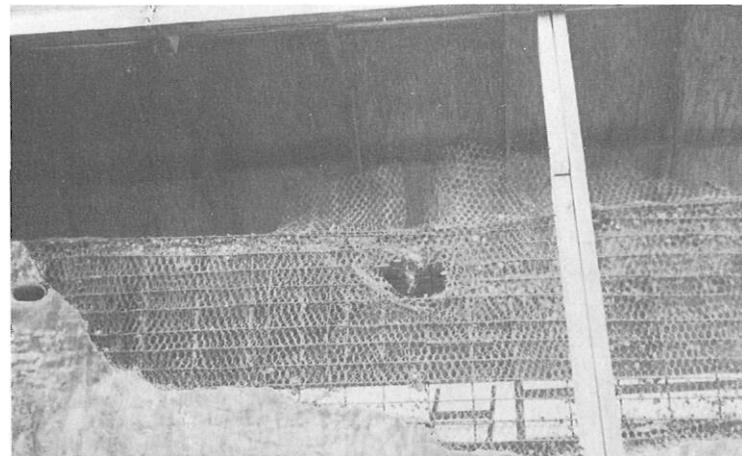
*Damaged area pounded out for repair.*

The loose mesh was clipped tight and smooth with hog rings.

The area was plastered in the same way as the hull. A grout slurry coat was painted over the cleaned joint. Wet sacks were hung over this new concrete surface for a week. This repair was totally successful and the repaired portion could not be discerned after the hull was painted.

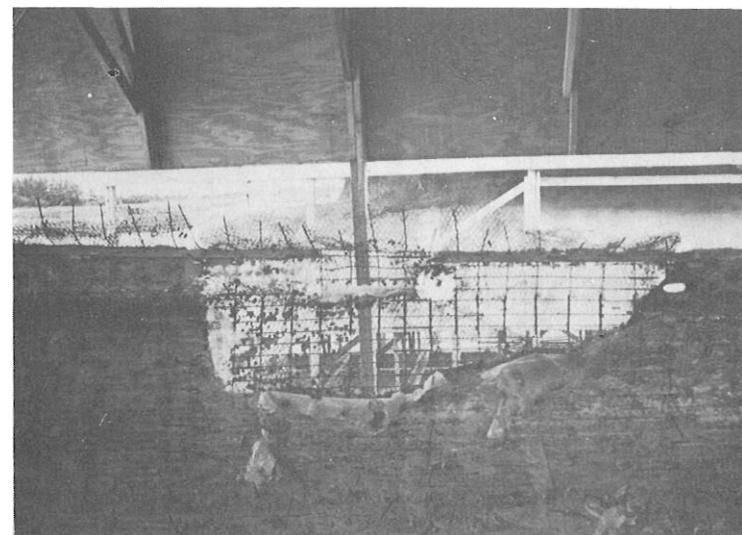
*View of same damaged area from inside.*

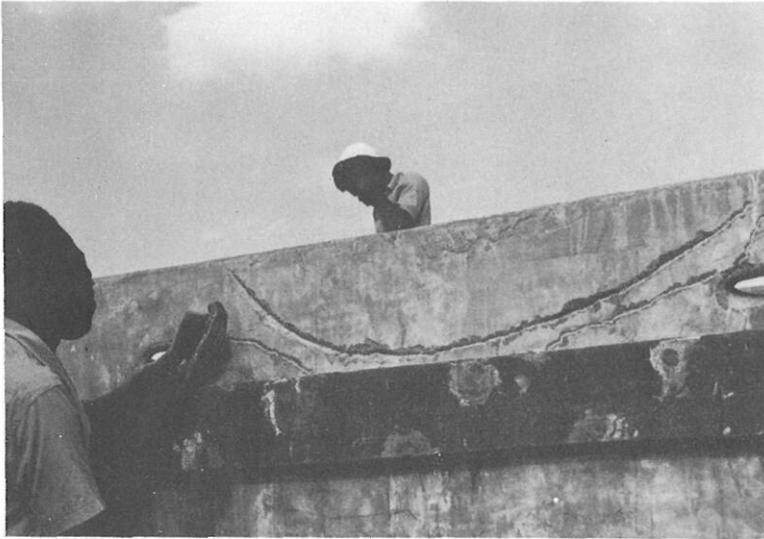
*Cracks being chipped open for repair.*

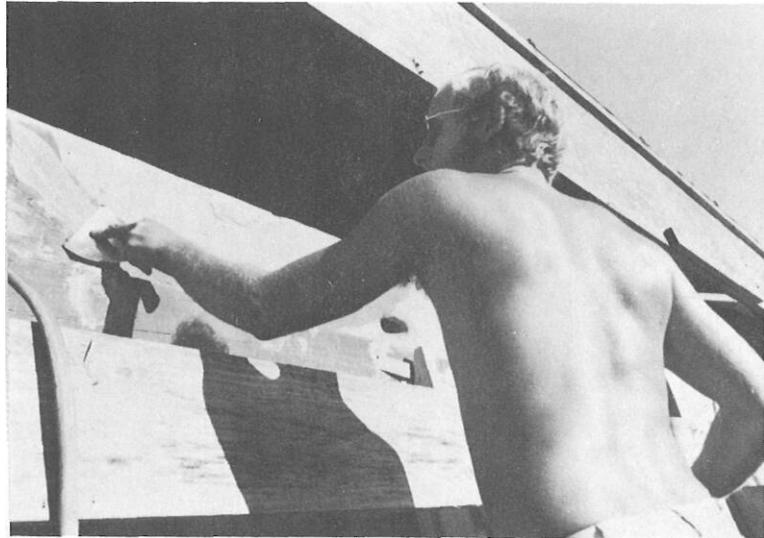
*Filling the cracks.*

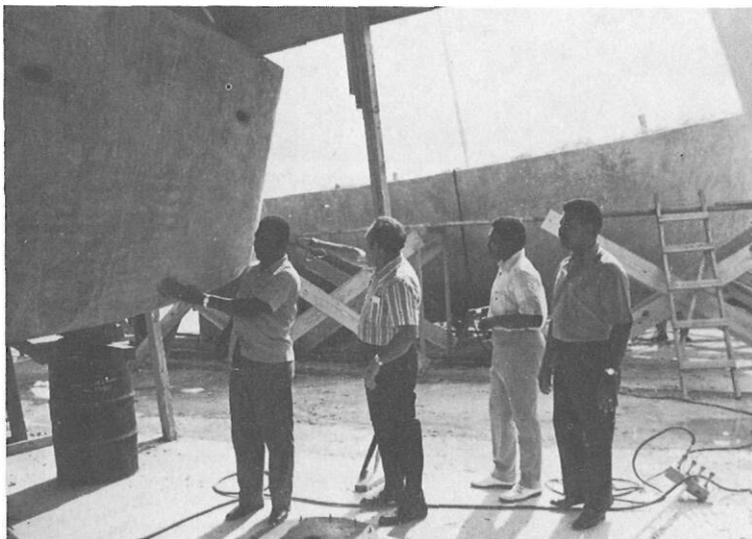
*Damage from a crow bar smoothly repaired.*
